Testimony of Bob Chipkevich
National Transportation Safety Board
Before the
U.S. House of Representatives
Committee on Transportation and Infrastructure
Subcommittee on Railroads, Pipelines, and Hazardous Materials
Hearing on Reauthorization of the Department of Transportation's
Hazardous Materials Safety Program
Baltimore, Maryland
November 16, 2009

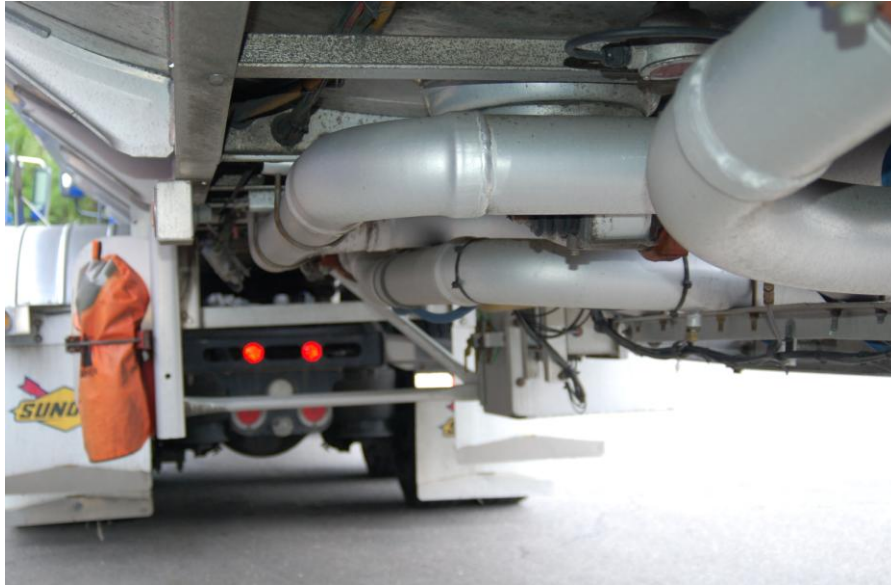
These external pipes or wet lines on a cargo tank semitrailer transporting flammable liquid may contain as much as 50 gallons of product underneath a fully loaded cargo tank. Because the wet lines are designed to break away in order to prevent damage to the tank shell, the wet lines could release a substantial amount of product on a striking passenger vehicle, which may be trapped beneath the cargo tank and engulfed in a fire. This issue predominately applies to tank trucks delivering gasoline to local gas stations.

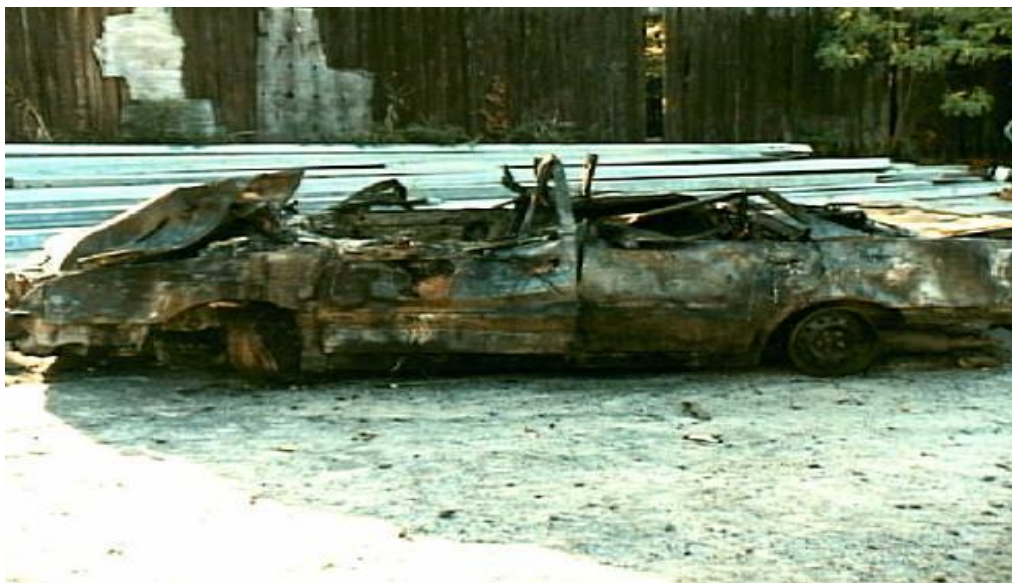
Subsequent to this rulemaking activity, the NTSB investigated several accidents in which wet lines were damaged, and gasoline in the wet lines was released and ignited. On October 9, 1997, a tractor/cargo tank semitrailer transporting 8,800 gallons of gasoline was struck by a car in Yonkers, New York. The car hit the right side of the cargo tank in the area of the tank's external wet lines, releasing the gasoline in them. The ensuing fire destroyed both vehicles, and the driver of the car was killed. Five months after this accident, the NTSB investigated a similar accident that happened on February 15, 1998, in Wilmington, Delaware. A tractor/cargo tank semitrailer transporting 8,900 gallons of gasoline struck the left rear of a car parked on the right shoulder of a bridge. The truck pushed the car into a concrete barrier bordering the bridge. A fire ensued, destroyed the car, and moderately damaged the truck.

The NTSB determined that three of the four wet lines on the cargo tank fractured during the collision, releasing about 12 gallons of gasoline. As a result of these investigations, the NTSB recommended that PHMSA prohibit the carrying of hazardous materials in external piping of cargo tanks, such as wet lines, which may be vulnerable to failure in an accident (Safety Recommendation H-98-27).

Prohibit the carrying of hazardous materials in external piping of cargo tanks, such as loading lines, that may be vulnerable to failure in an accident. (H-98-27);
Current classification: Open—Acceptable Response

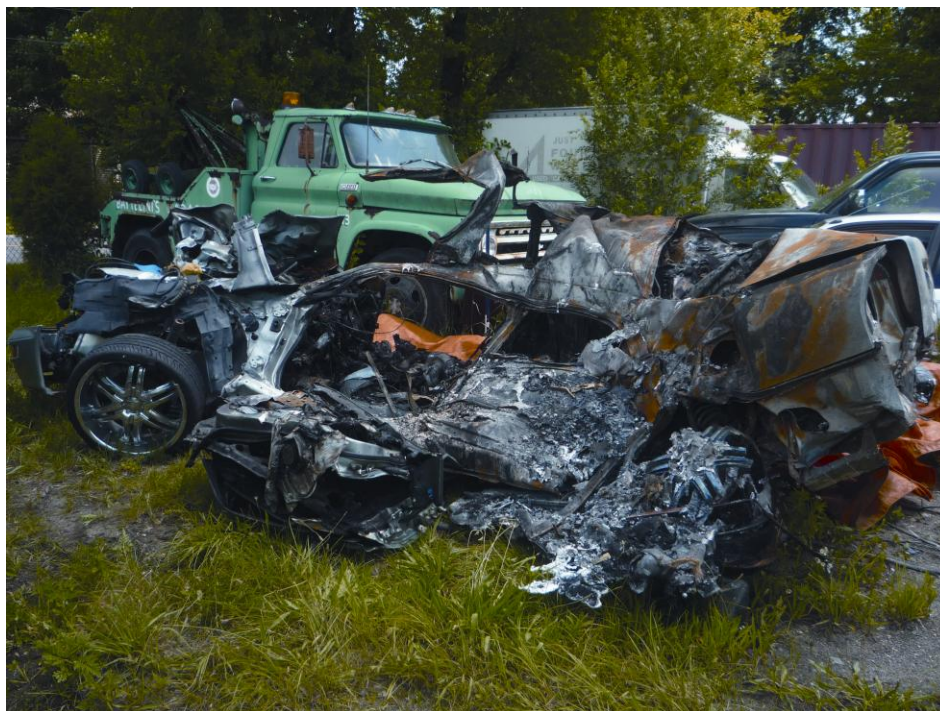
On July 1, 2009, an automobile collided with a cargo tank semitrailer in Upper Pittsgrove Township, New Jersey. The automobile struck a wet line on the cargo tank truck and about 13 gallons of gasoline were released onto the automobile. The wet line did not sever at the point where it is connected to the cargo tank. The wet line was originally about 18 feet long and 4 inches in diameter. Approximately 6 feet of the wet line remained attached to the cargo tank after the accident, extending from where it was attached to the number 4 cargo compartment forward towards the piping manifold. The automobile became wedged beneath the cargo tank truck and a postcrash fire consumed the automobile. The Gloucester County Medical Examiner's Office postmortem report indicated that the cause of death of the automobile driver was smoke and soot inhalation and severe thermal burns. NTSB investigated the accident and determined that the probable cause of the accident was the failure of the automobile driver to obey a stop sign equipped with flashing red lights. Contributing to the severity of the accident was a fire that resulted from the release of gasoline from a cargo tank loading line that was ruptured during the collision.

This recent accident illustrates once again why the NTSB strongly believes that PHMSA should prohibit the unsafe practice of transporting hazardous materials in the external loading lines of cargo tanks.

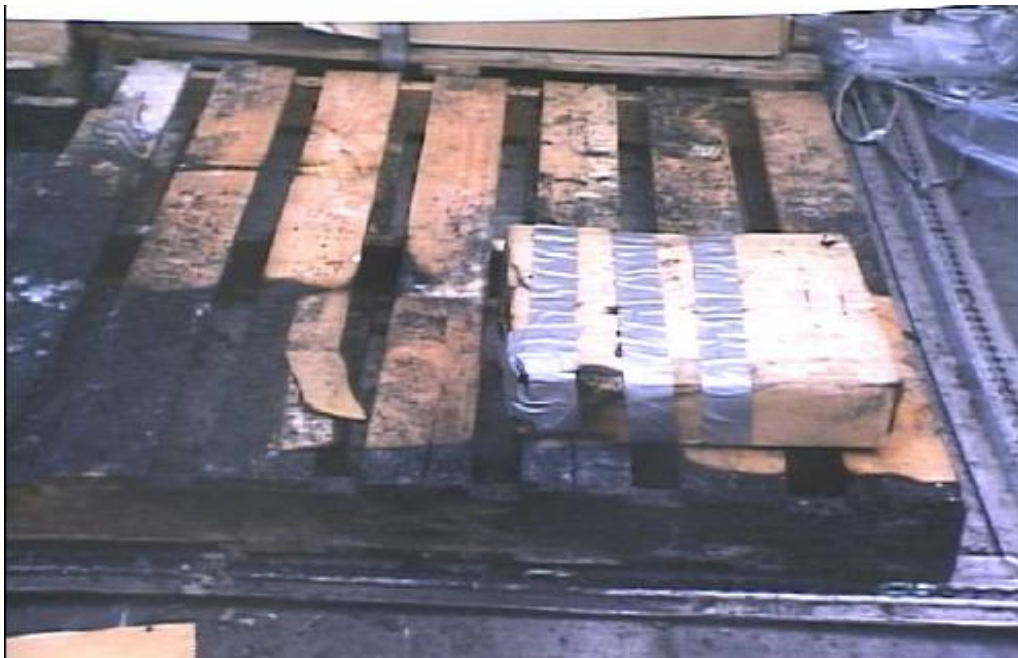
On April 28, 1999, a fire destroyed two cargo pallets that included boxes of primary lithium batteries at Los Angeles International Airport. The pallets had been taken off an inbound passenger-carrying flight from Japan. During the movement of one of the pallets by a forklift within the cargo facility, the pallet fell off the forklift and rolled onto its side against another pallet. The pallet of primary lithium batteries was moved a second time and placed next to another pallet of primary lithium batteries. Three minutes later, smoke and a small fire were observed on the previously overturned pallet. The fire spread to the adjoining pallet of batteries, and both pallets erupted in flames. The fire department extinguished the fire in about 25 minutes only after separating the packages on the pallets and deluging them with water.

The lithium batteries on the two pallets were neither identified nor shipped as hazardous materials. Instead, they had been shipped as ordinary freight under an exception to the *Hazardous Materials Regulations*. At the time of this incident, lithium batteries containing limited amounts of lithium and meeting certain packaging requirements were "excepted" (excluded) from all regulations. Lithium batteries not meeting the exception criteria had to be transported as a regulated hazardous material, be identified on the shipping documents, and have appropriately marked and labeled packaging. The batteries involved in this incident met the criteria for the exceptions.

The NTSB's investigation of this incident revealed that these batteries presented an unacceptable risk to aircraft and passengers. The NTSB recommended that PHMSA with the Federal Aviation Administration (FAA), evaluate the fire hazards posed by lithium batteries in an aviation environment and require that appropriate safety measures be taken to protect the aircraft and occupants. The NTSB also recommended that packages containing lithium batteries be identified as hazardous materials, including appropriate marking and labeling of the packages and proper identification in shipping documents when transported on aircraft.

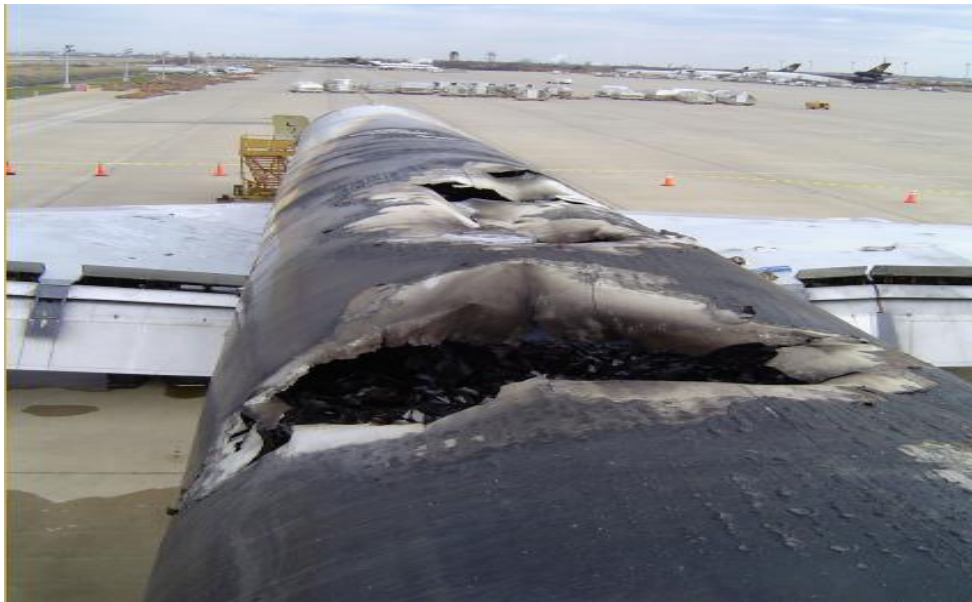
The most recent accident that involved lithium batteries and was investigated by the NTSB occurred on February 7, 2006. After an in-flight cargo fire, a cargo aircraft made an emergency landing at its destination airport, Philadelphia International Airport. The aircraft and most of the cargo were destroyed by fire after landing.

The NTSB examined the contents of the cargo containers where the fire most likely originated and found that several electronic devices containing secondary lithium batteries were shipped in these containers. No batteries were found that exhibited any damage identifying a source of ignition, nor could any determination be made that secondary batteries found in the debris had been subject to recalls.

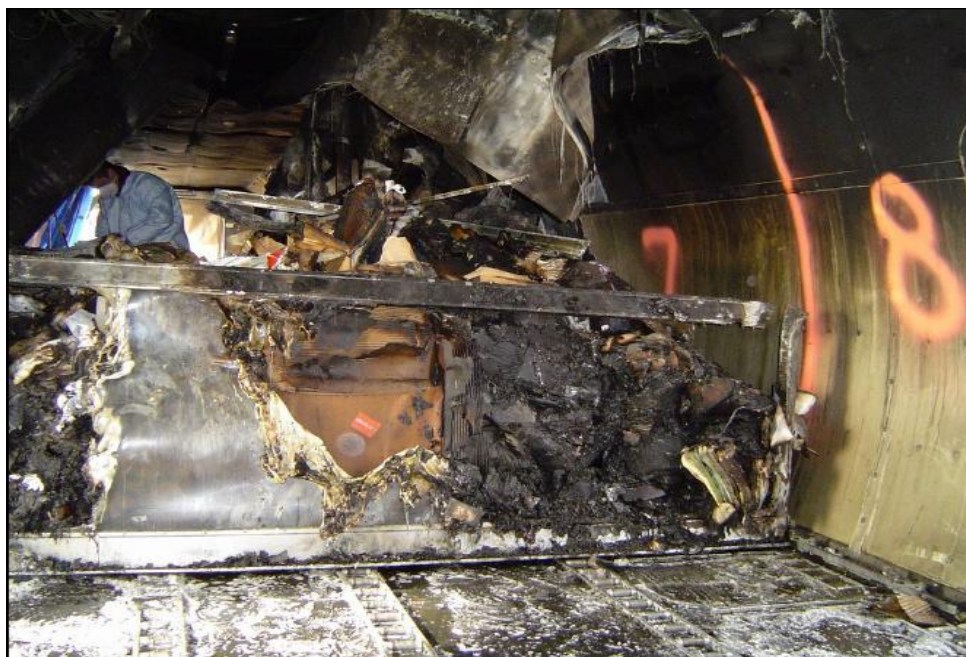
Although the cause of the in-flight fire ultimately could not be determined, the prevalence of electronic equipment in the main cargo compartment caused the NTSB to closely examine safety issues involving the transportation of secondary lithium batteries on commercial aircraft, including batteries in airline passengers' laptop computers and other personal electronic devices. The NTSB concluded from its investigation that testing and incident data indicated that both primary and secondary lithium batteries pose a fire hazard, and that an in-depth analysis of the causes of primary and secondary lithium battery failures would improve the safe transportation of these batteries.
